## MARYLAND HISTORICAL TRUST

# INVENTORY FORM FOR STATE HISTORIC SITES SURVEY

The Swallow Falls-Herrington Manor State Parks are located within Swallow Falls State Forest northwest of Oakland in Garrett County, Maryland.

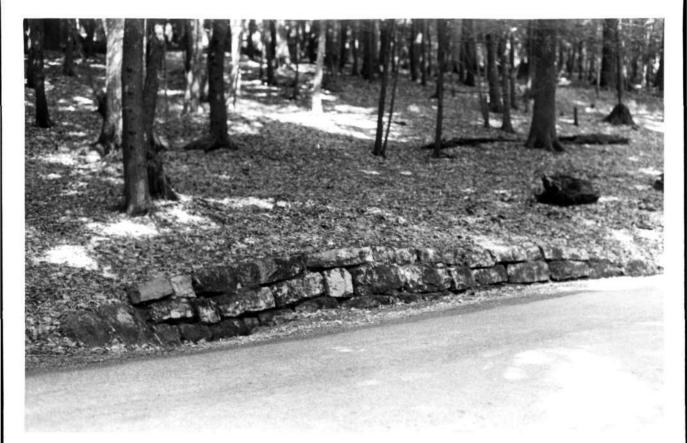
G-IV-A-011

Most of the older structures within these parks date from the 1930s and were built by the Civilian Conservation Corps. Within Swallow Falls State Park are several stone and log pavilions, a frame structure now used as an office, and stone drainage culverts dating from the 1930s.

G-IV-A-OII Swallow Falls St. Park Stone Culvert W. View August, 1978
